# UPGRADING THE ENERGY PERFORMANCE OF ELMEHUSET IN THE OLD PEOPLE'S TOWN

REPORT - PRODUCED FOR SBI OCTOBER 2012

KANT ARCHITECTS A/S / RYESGADE 19C, 2.SAL / 2200 KØBENHAVN N / RIKKE MUNCH

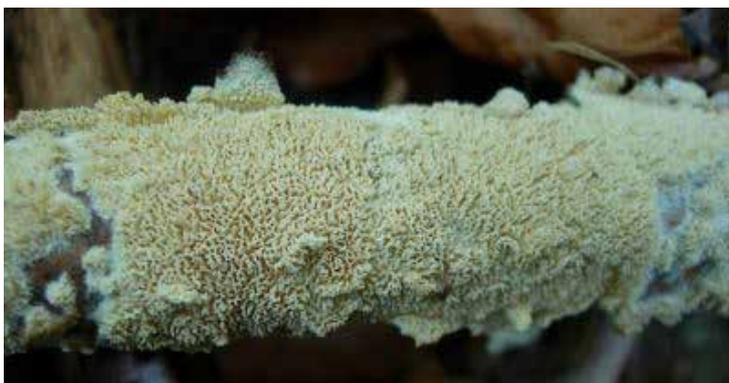
White dry rot

The preliminary investigations around the roof showed that the roof structure had been heavily attacked by white cellar fungus, mould growth and dry rot because of faults in the roof underlay, guttering etc. This meant that the entire roof covering, underlay and battens had to be replaced, and the framework repaired. As new insulation was to be applied, which requires increased rafter depth, and the straightening of existing rafters on the outside and inside was required, it was deemed to be more rational to budget for a totally new set of roof rafters. The administrator (KEjd) therefore decided to replace the entire roof structure.

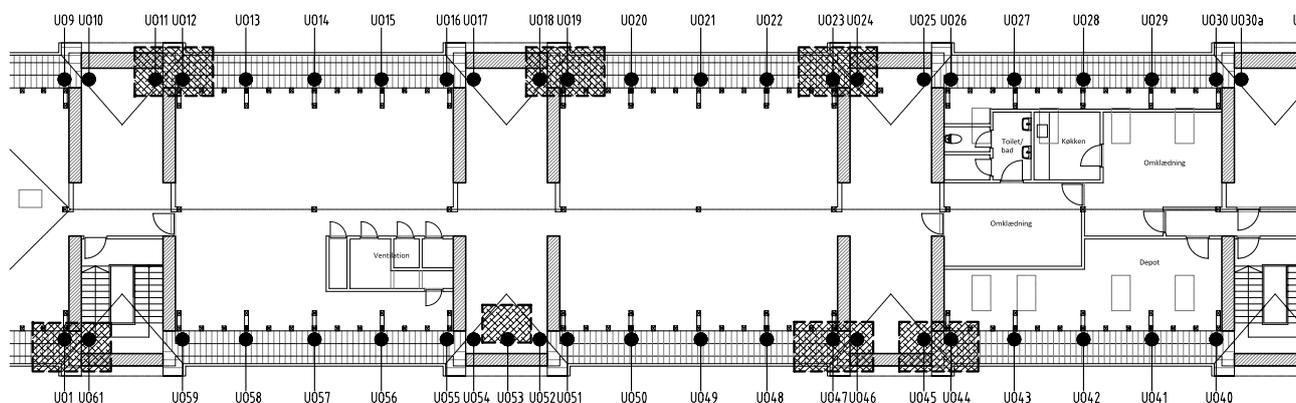
Registration of mould and dry rot attack in roof structure

The roof construction needed replacing due to rot and mould attack. The scope and location of mould damage indicated that the existing roof construction had been installed incorrectly, and that the Haloten roof underlay prevented the necessary level of ventilation. Extra focus was therefore placed on the sealing and ventilation of a new roof construction.

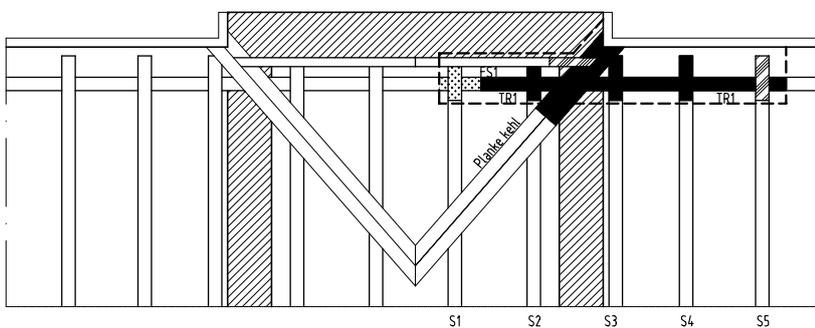
*Rafter construction with mould attack, white dry rot*

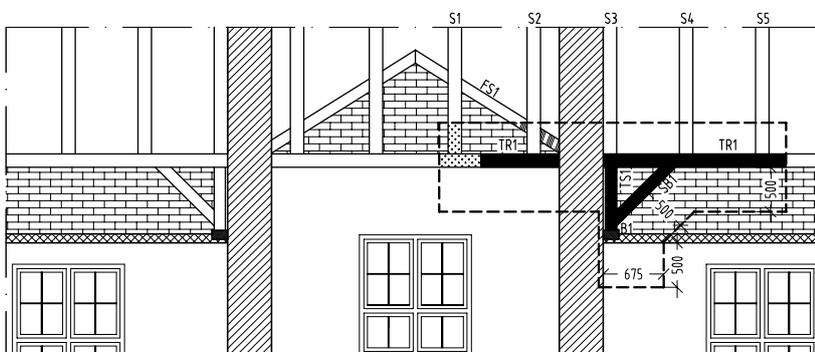
*Facade (from inside) area with mould attack, white dry rot*

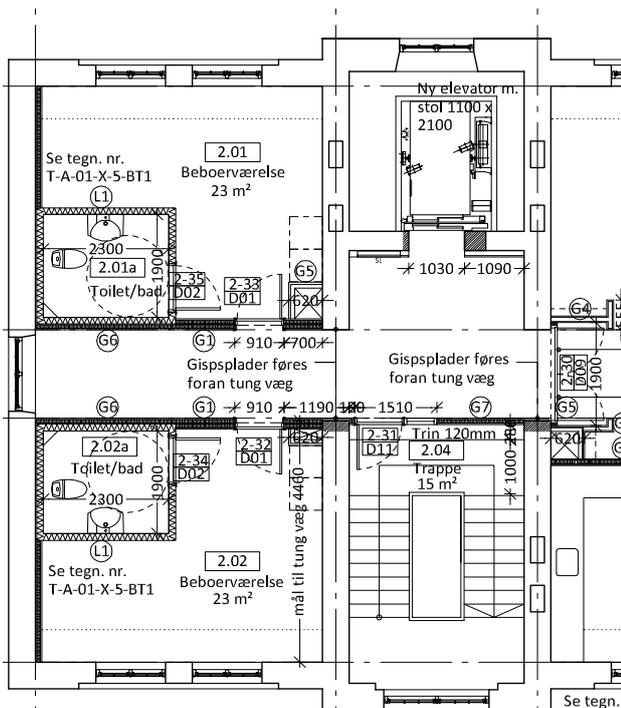
Insulation at gable end walls

The secondary wall is a 120 mm thick stud wall, into which 70 mm mineral wool insulation was inserted. The structure stands 25 mm from the heavy outer wall across its full width and height. A vapour barrier was fitted and the wall clad with two layers of 12.5 mm plasterboard, with the outer layer in robust sheets. A soft grout was applied in the joints between adjacent building elements.

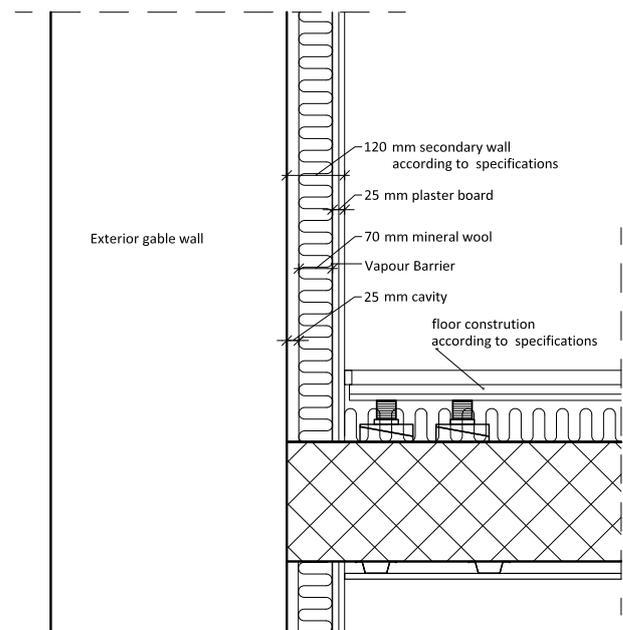
Insulated gable end wall, section
