# ENERGY EFFICIENCY IMPROVEMENT POTENTIAL IN HISTORICAL BRICK BUILDING

Andra Blumberga, Gatis Zogla, Kristaps Zvaigznitis, Dagnija Blumberga  
Riga Technical University  
2013

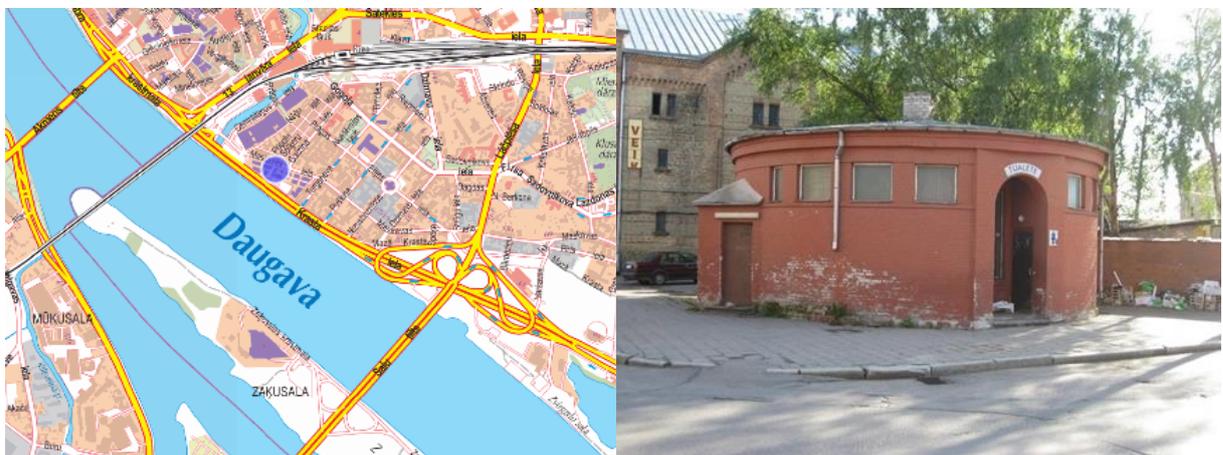
Fig. 1. Building Maskavas Street 8, Riga, location and facade

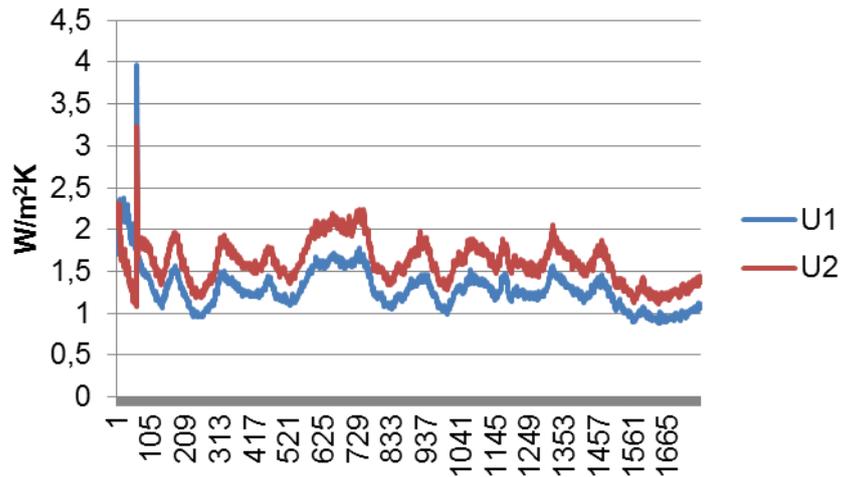
During the measurements heat flows in brick walls are determined. Before the installation of heat flows density measuring equipment measurement sites were surveyed with the help of termocamera, to make sure that the measurement point does not contain thermal damage, which could reduce the measurement accuracy. Figure 2. displays instantaneous heat transfer coefficients of the walls of Maskavas Street 8.

Fig. 1.10 Instantaneous heat transfer coefficients of the walls of Maskavas 8

3. Calculated heat transfer coefficient is lower (1.32 W / mK) than measured (1, 48 W / mK).
4. Moisture and freeze - thaw cycles have done grate damage to external wall structures of Maskavas Street building. The main cause of damage is poor technical condition of roof gutters. While the main reasons for masonry cracking are three: the intense traffic and transport, poor foundations and groundwater fluctuations.
