Technical condition, indoor climate and renovation demand of brick apartment buildings in Estonia

Renovation demand of brick apartment buildings in Estonia

- National research project: *“Technical condition and service life of Estonian brick apartment buildings”* 2009-2010
 - The main objectives:
 - Survey of technical condition of typical brick apartment buildings;
 - Investigate the indoor climate and energy performance of buildings;
 - Determine the main demands of renovations of brick apartment buildings.
 - Characterization of studied brick apartment buildings:
 - 30 buildings, constructed between 1940 and 1990, 4-9 storey;
 - From each building one to three apartments were selected to the indoor climate and building physics studies (50 apartments);
 - All the buildings and apartments studied were in private ownership.
 - The research was financed by Credit and Export Guarantee Fund KredEx and Tallinn University of Technology

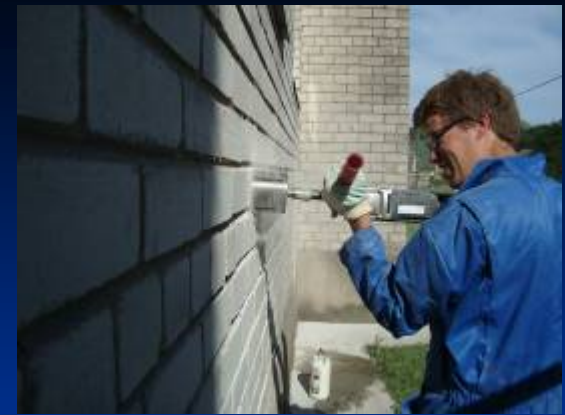
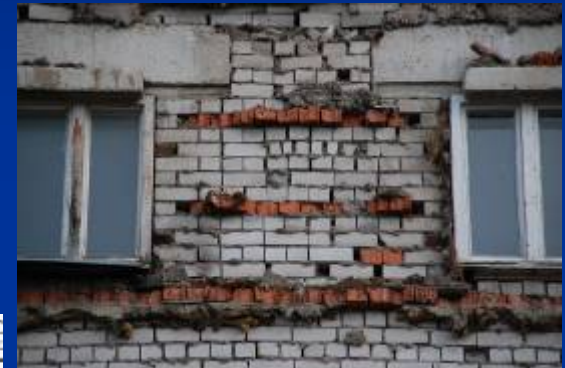
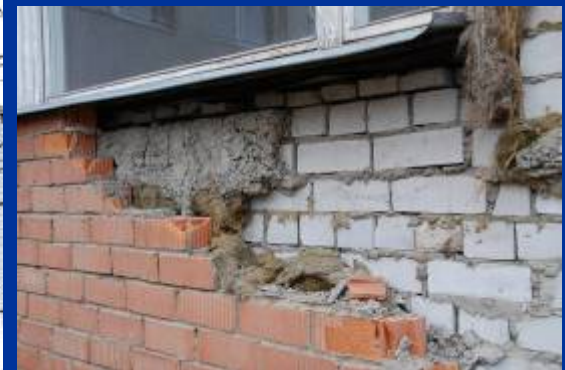
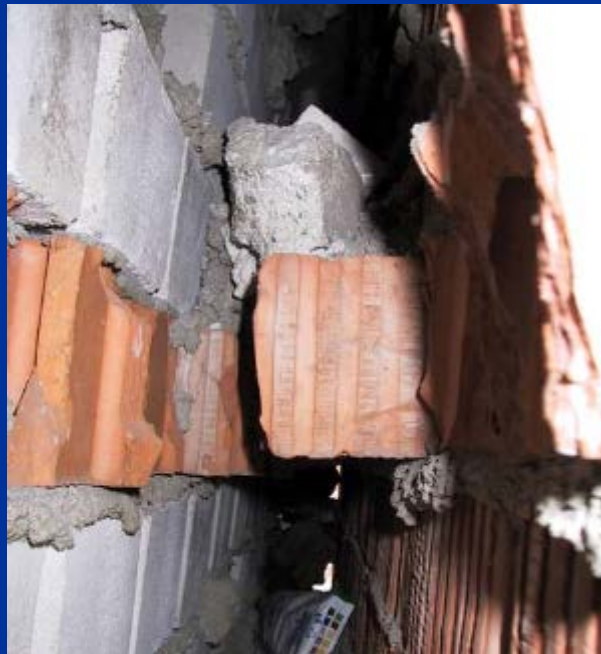
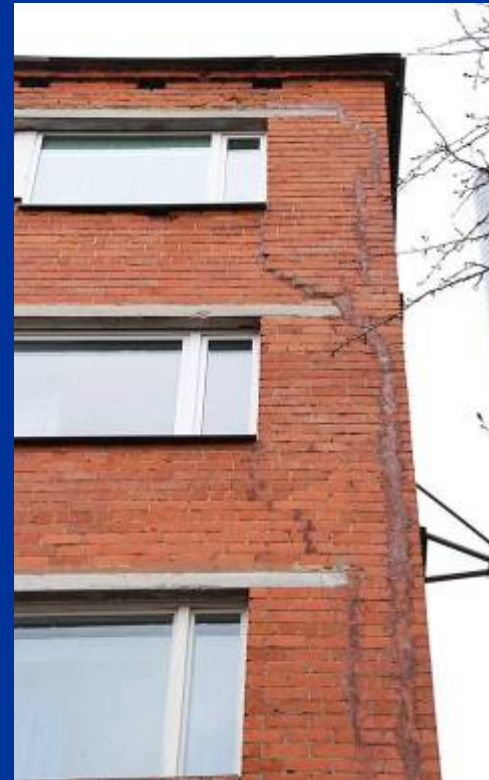
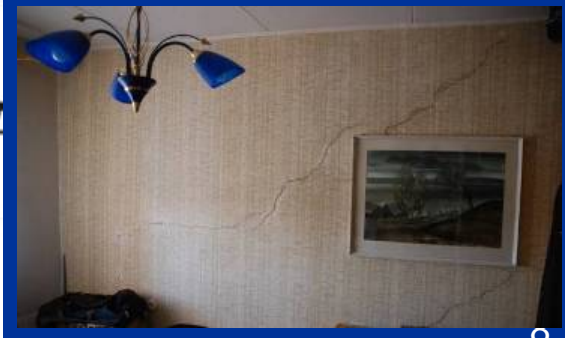
- **Investigation of building envelope**
 - survey of technical condition of the structures (walls, floors, roofs, balconies)

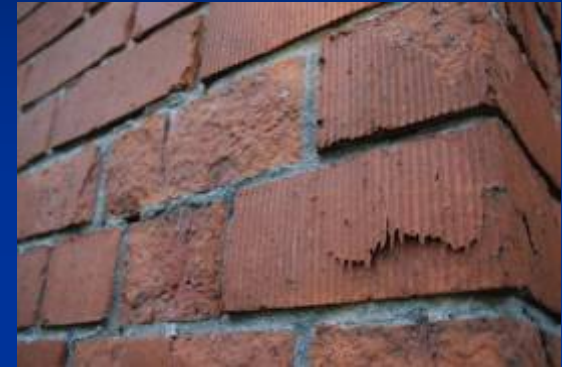
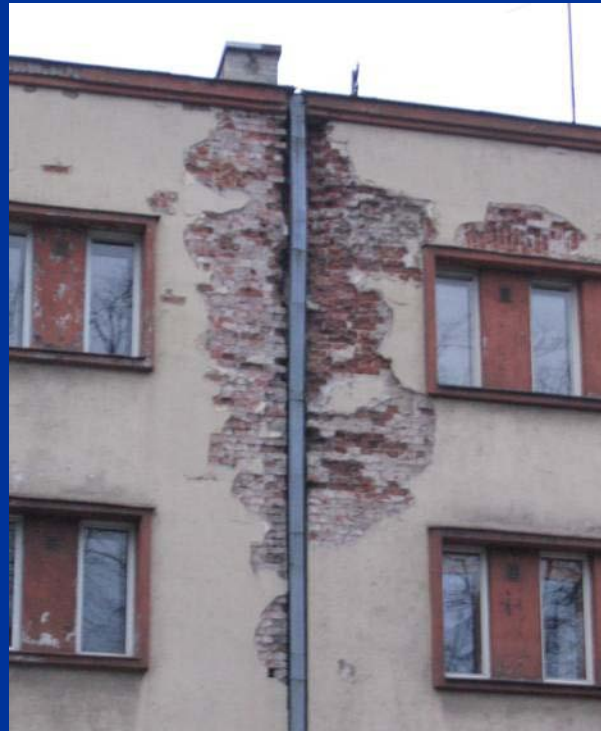
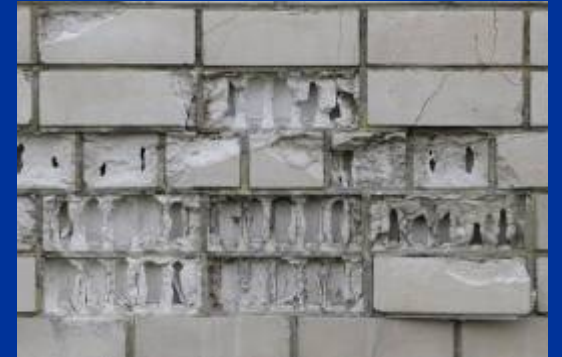
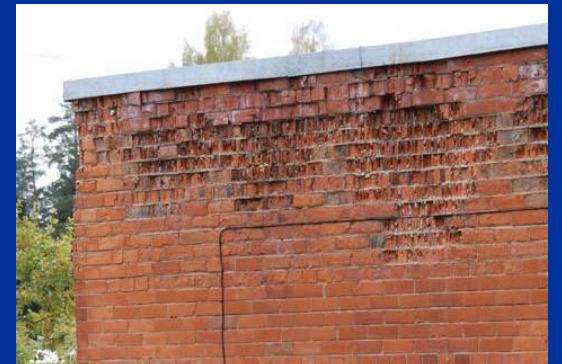
- **Investigation of building envelope**
 - survey of technical condition of the structures (walls, floors, roofs, balconies)
 - frost resistance of the facades

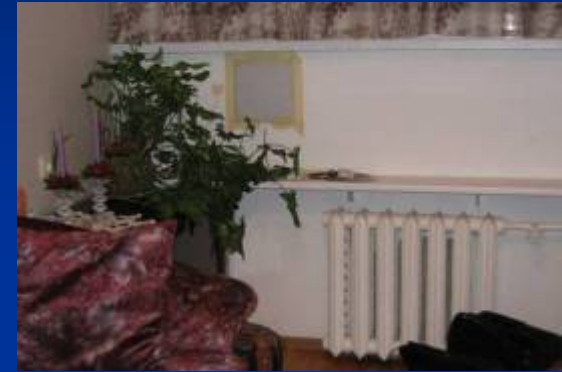
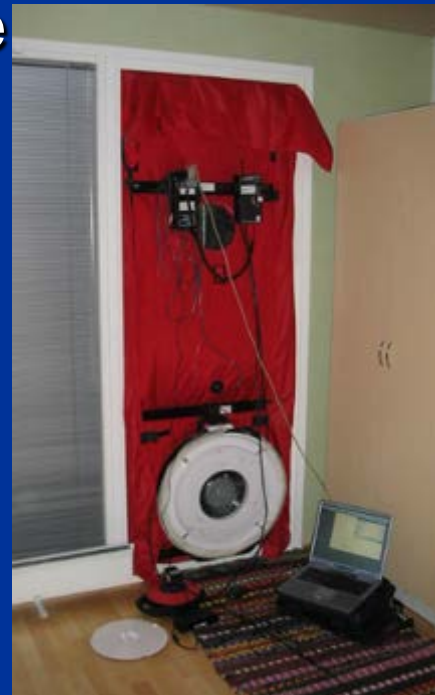
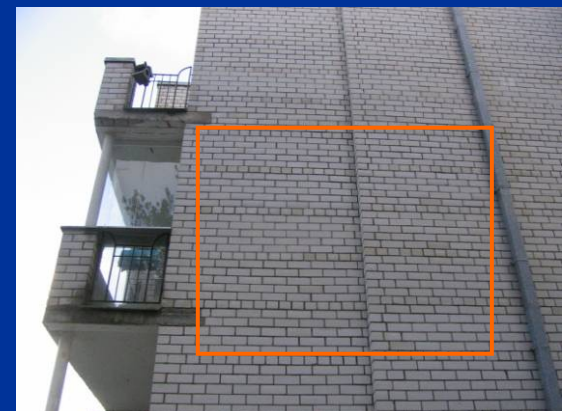
- survey of technical condition of the structures (walls, floors, roofs, balconies)
- frost resistance of the facades
- thermal transmittance and thermal bridges of building envelope
- air tightness of building envelope

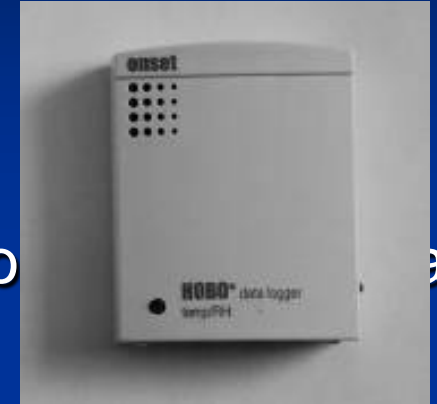
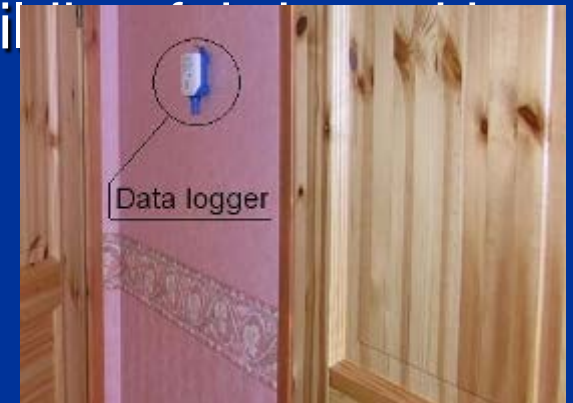
- Investigation of building envelope;
- **Indoor climate, hygrothermal conditions**
 - indoor temperature and RH over one year period at o
 - indoor CO₂, performance of ventilation
 - microbiological contamination on surfaces of built indoor air

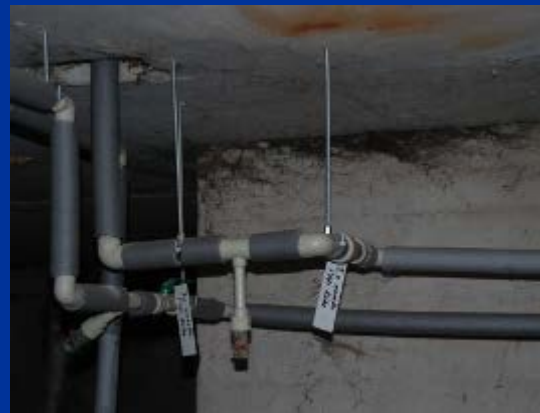
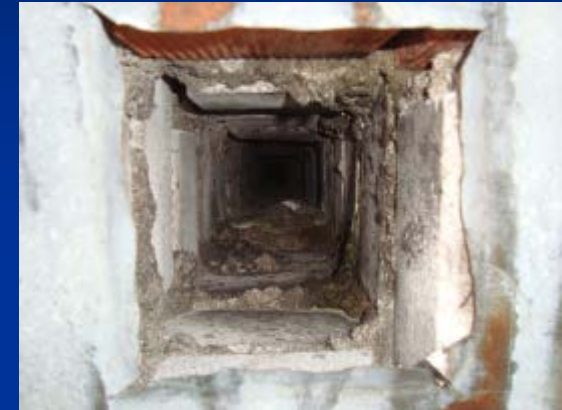
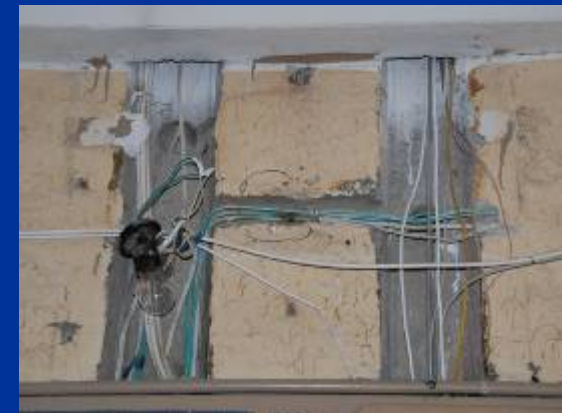
- Investigation of building envelope;
- Indoor climate, hygrothermal conditions
- **Conditions of building services**

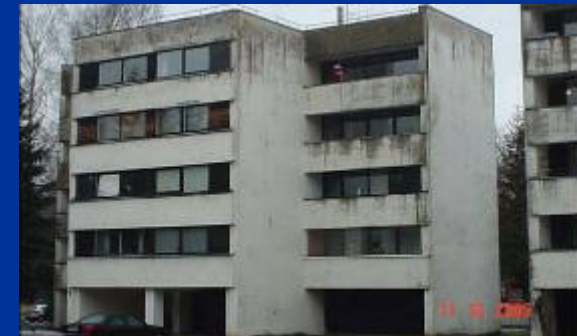
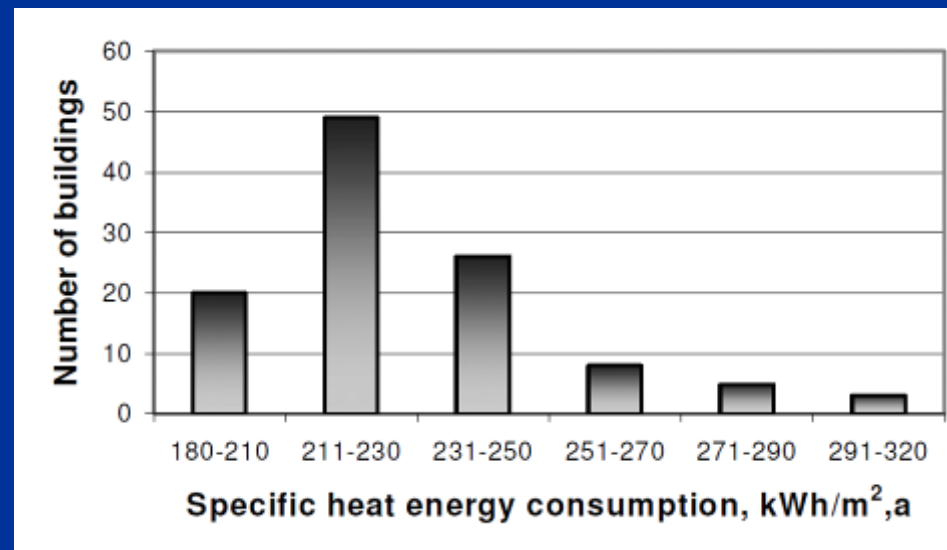
- Investigation of building envelope;
- Indoor climate, hygrothermal conditions
- Conditions of HVAC systems
- **Measurement and simulation of energy use**

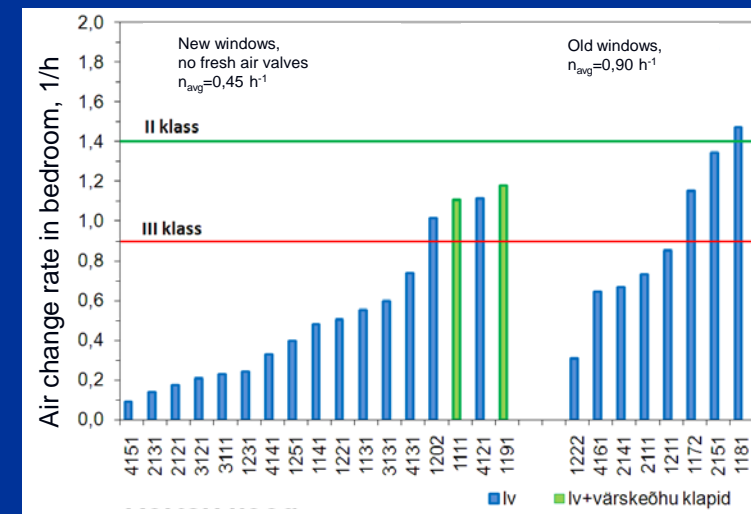
- Typical problems of existing systems:
 - natural ventilation (passive stack, window):
 - low air change,
 - low indoor air quality,
 - high moisture load,
 - no heat recovery: large energy consumption,
 - impossible to regulate air flows,
 - air inflow from stack (wind),
 - air tightness of old ventilation channels,
 - the replacement of windows without renovation of ventilation:
 - smaller leakage rate,
 - more airtight building envelope.

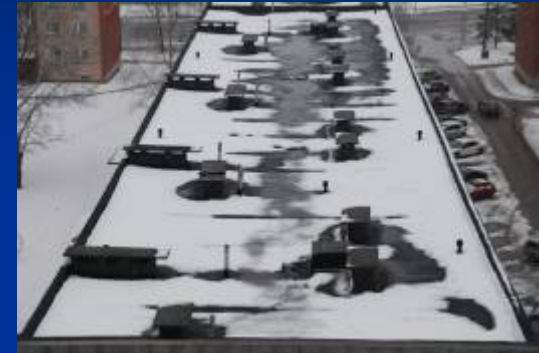
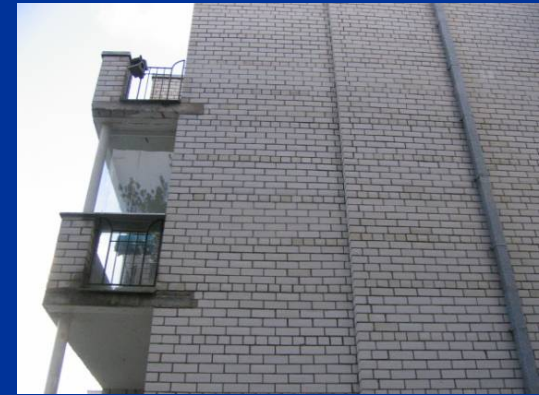
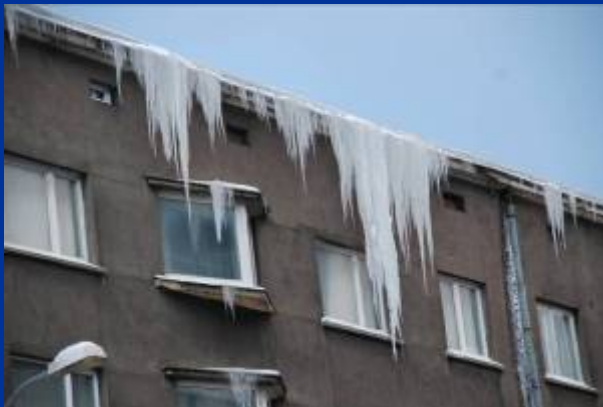
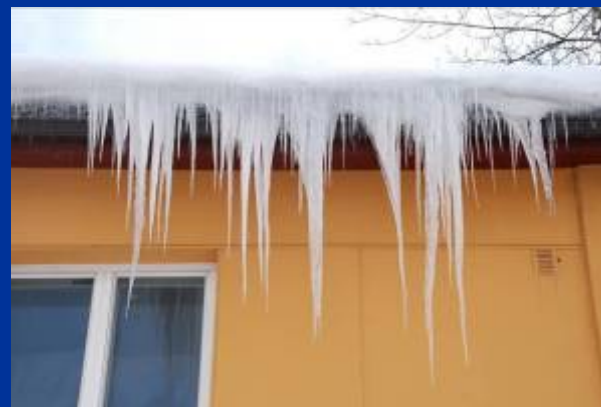
■ **high thermal transmittance:**

- external walls $0.5\text{--}1.2 \text{ W}/(\text{m}^2\cdot\text{K})$,
- roof-ceilings $0.7\text{--}1.0 \text{ W}/(\text{m}^2\cdot\text{K})$,
- windows $2\text{--}3 \text{ W}/(\text{m}^2\cdot\text{K})$.

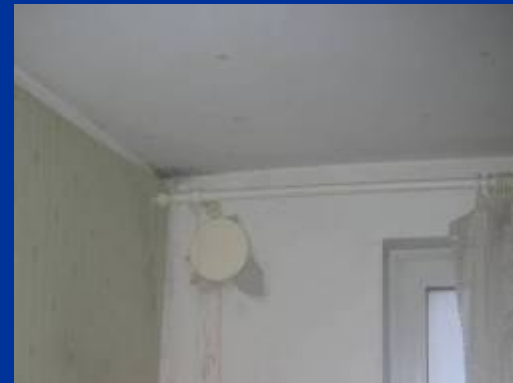
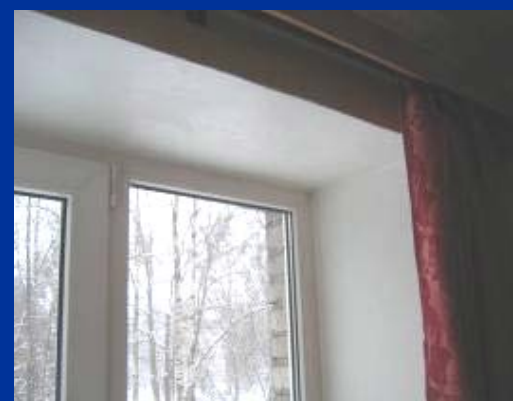
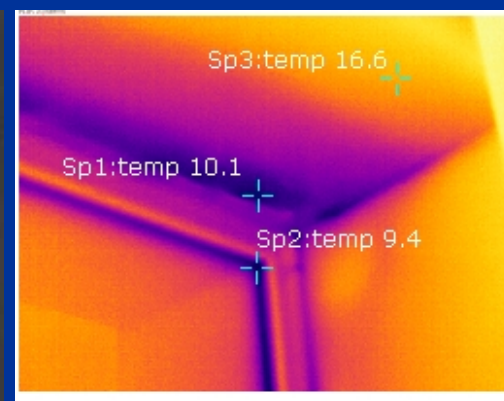
- Existing problems:
 - **high thermal transmittance**
 - **serious thermal bridges:**
a large problem especially in old apartment buildings

mould growth and surface condensation on the internal surfaces of thermal bridges is unavoidable without:

- lowering thermal transmittance,
- lowering internal humidity loads.

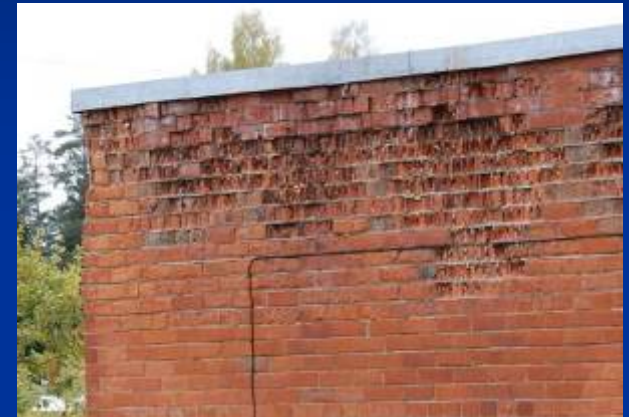
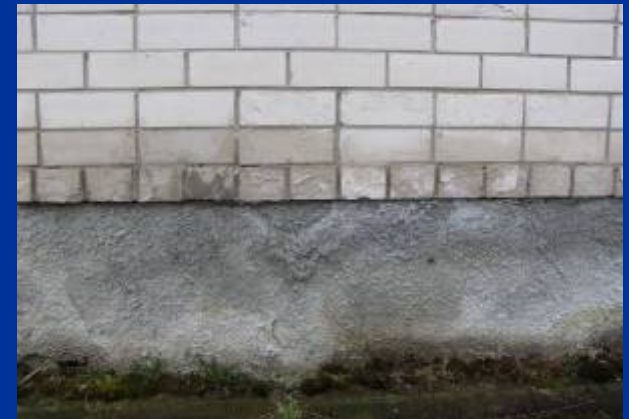
- Existing problems:
 - **high thermal transmittance:**
 - **serious thermal bridges:**
also big problem in old apartment buildings already additionally insulated (windows)
 - **low frost resistance:**
a need to protect facade,
 - **carbonization of mortar,**
 - it is economically reasonable to make the additional thermal insulation for walls and roofs (strong pressure).
 - cultural value should be preserved

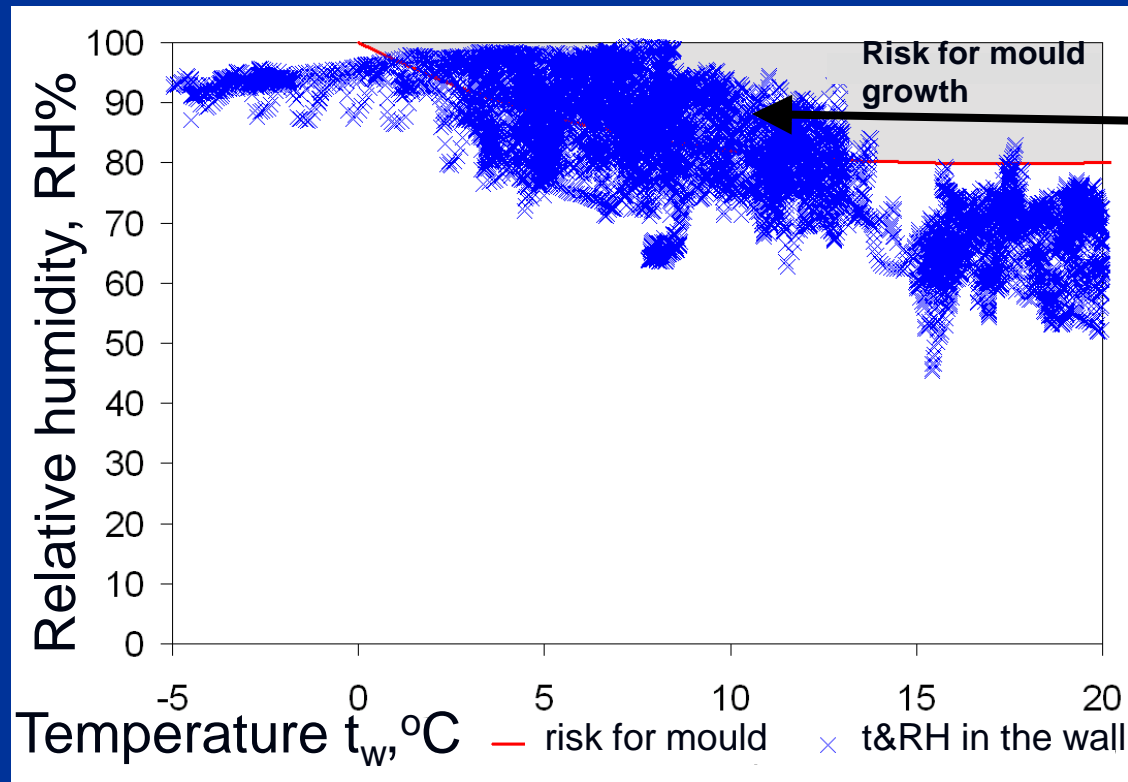
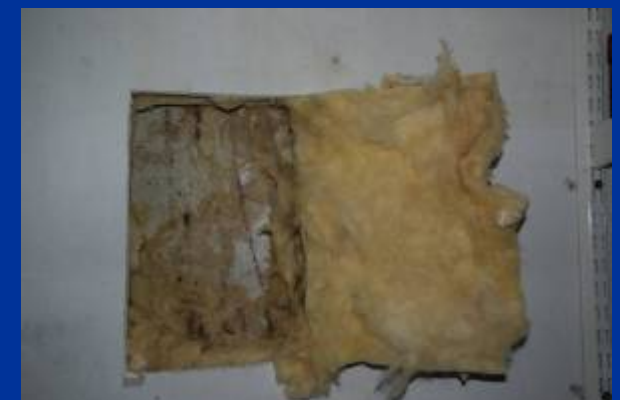
- Internal thermal insulation is risky solution in cold climate: mould growth and condensation in the wall on the old wall surface

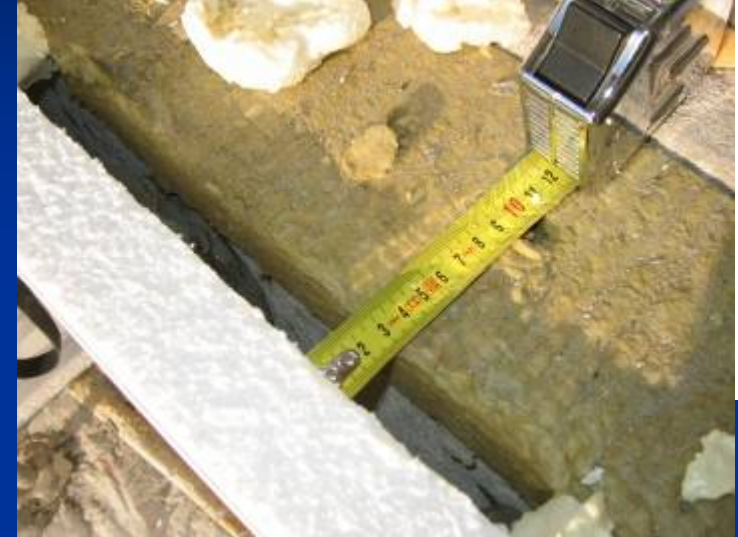
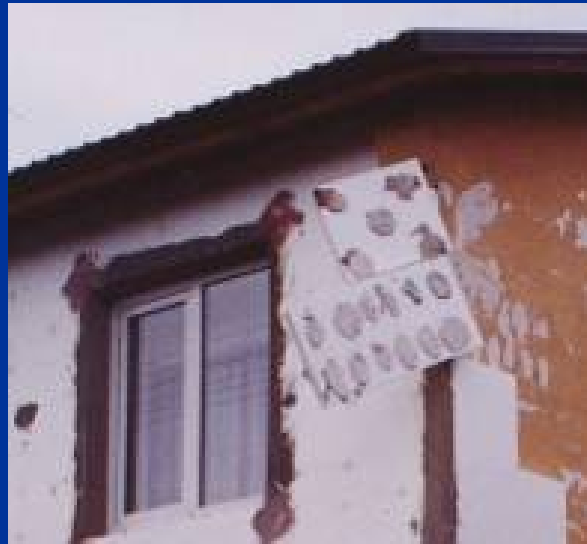
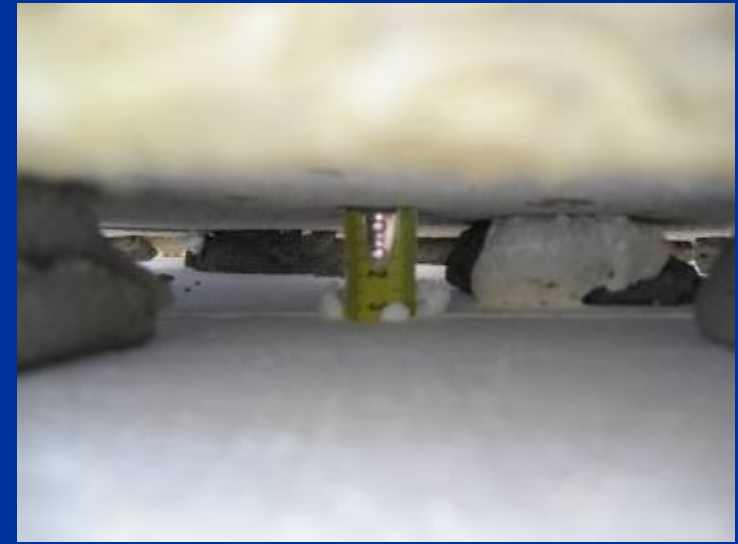
- Typical problems with the additional insulation:
 - **Windows**: old or new, on its original place
 - **Low quality**: air space between old wall and new insulation;

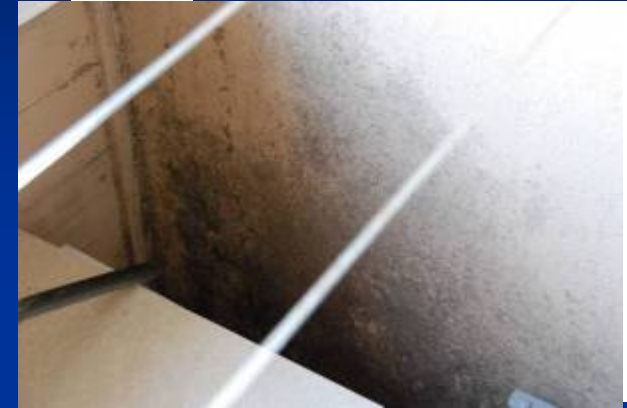
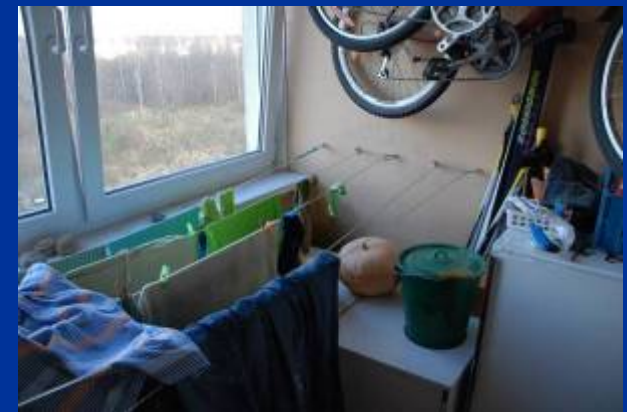
- Typical problems with the additional insulation:
 - **Windows**: old or new, on its original
 - **Low quality**: air space between old wall and new insulation;
 - **Loggias**: thermal bridges, mould

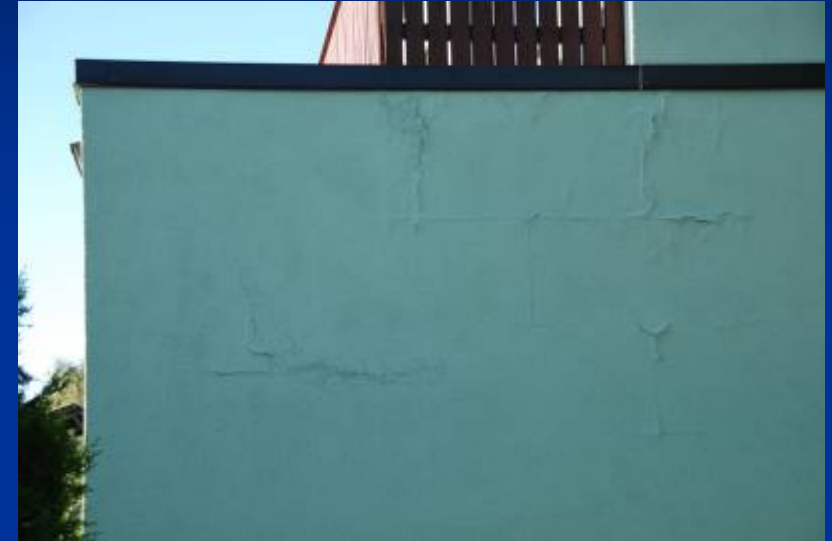
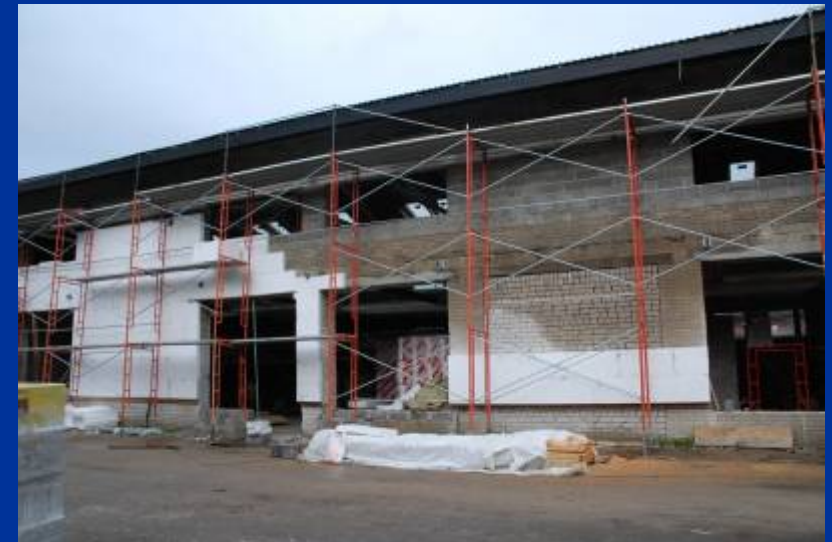
- Typical problems with the additional insulation:
 - **Windows**: old or new, on its original
 - **Low quality**: air space between old wall and new insulation;
 - **Loggias**: thermal bridges, mould
 - Drying out of **structural moisture**

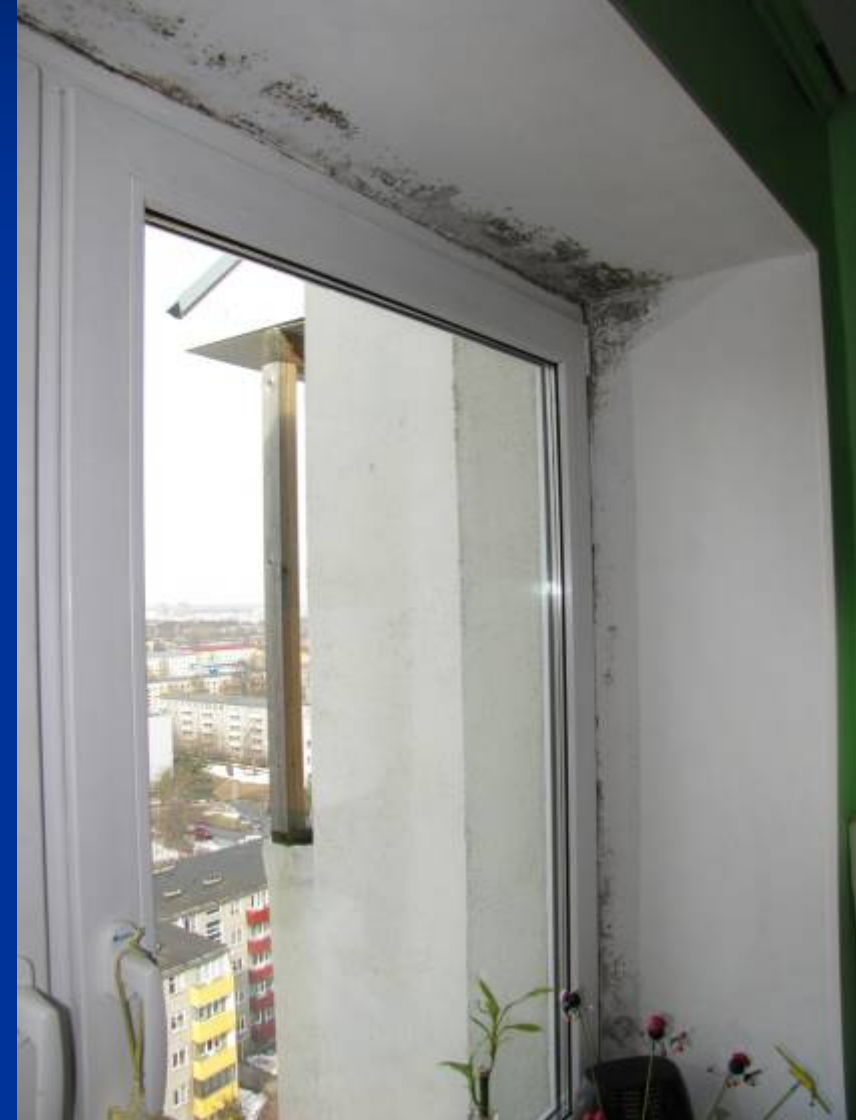
- Typical problems with the additional insulation:
 - **Windows**: old or new, on its original
 - **Low quality**: air space between old wall and new insulation;
 - **Loggias**: thermal bridges, mould
 - Drying out of **structural moisture**
 - **Complex renovation** (ventilation + building envelope + heating systems) is not common: mould after insulation (ventilation was not renovated)

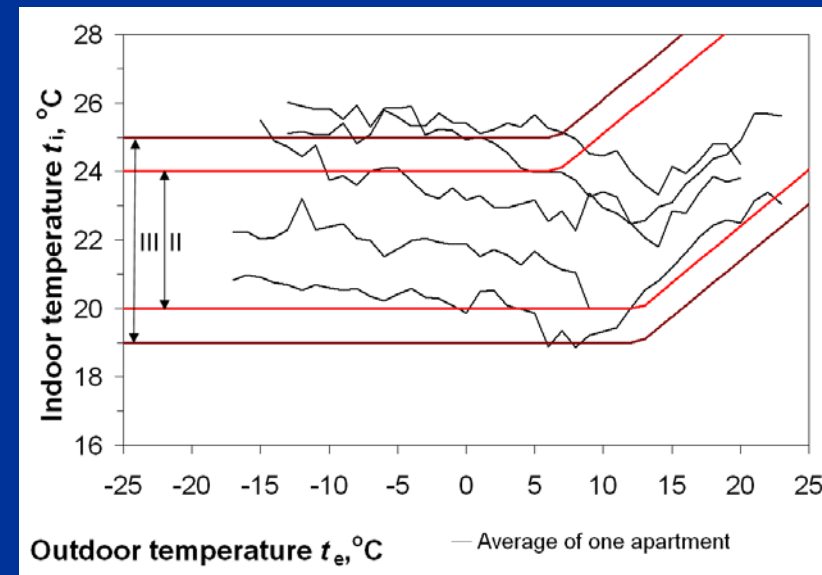
- Typical solution:
 - one-pipe heat distribution system;
 - no room thermostats on radiators;
- Typical problems:
 - incorrect control curve of the temperature of the supply water of the heating system,
 - incorrect water flow rate of the risers of the heating system,
 - lack of direct room temperature control,
 - difficulties to balance the one-pipe heat distribution system,
 - lack of maintenance and improper modifications of the heating and ventilation systems.
