Co₂olBricks

Post-insulation of outer walls

Educational product: New lecture material for training modules dealing with knowledge and skills how to apply suitable methods of energy efficient refurbishment of historic constructions and how innovation can be combined with cultural heritage

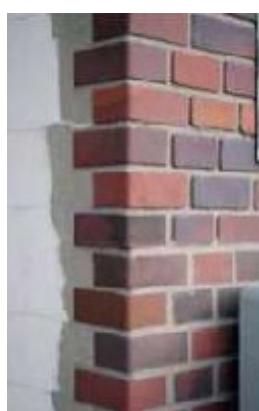
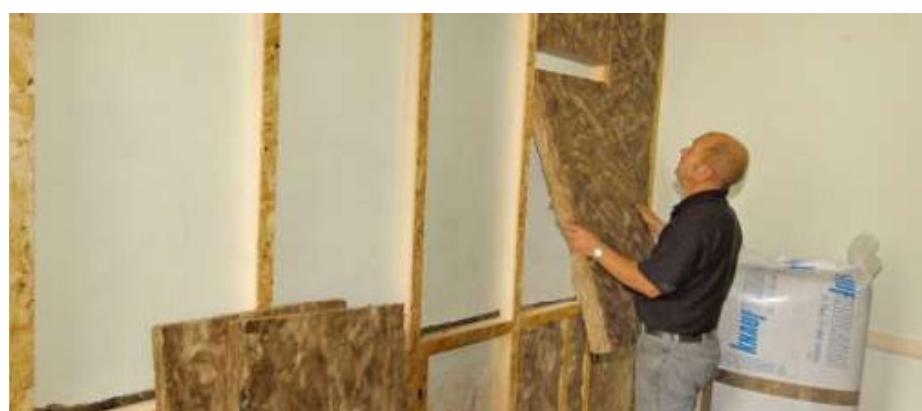
External insulation

Internal insulation

Fig. 18. Insulation material for external insulation has to imitate bricks if it is while internal insulation has no such needs [http://www.sustainablebuildingsolutions.co.uk/training_courses/thermoshell-internal-wallinsulation-installer]

If wall is insulated from inside then the usual solution is a wooden carcass, which is filled with insulation material and afterwards covered with gypsum boards or other finishing materials. If wall is insulated from outside then for historical brick buildings there is a solution where the insulation board imitates brick masonry.
