# UPGRADING THE ENERGY PERFORMANCE OF ELMEHUSET IN THE OLD PEOPLE'S TOWN

REPORT - PRODUCED FOR SBI OCTOBER 2012

KANT ARCHITECTS A/S / RYESGADE 19C, 2.SAL / 2200 KØBENHAVN N / RIKKE MUNCH

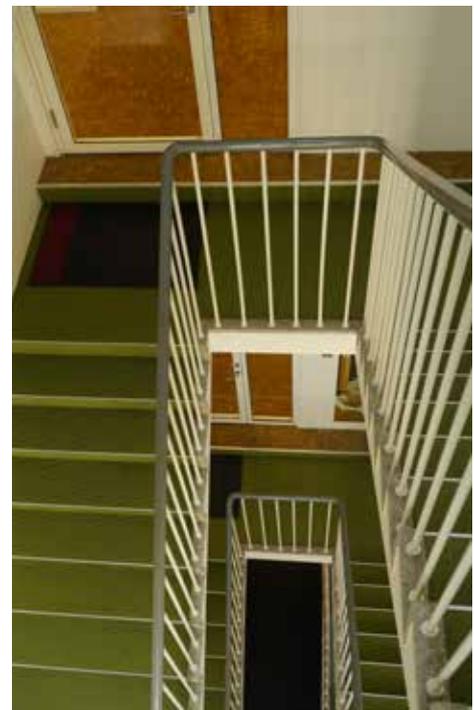
This would involve special acoustic insulation of all floors, which entailed extensive conversion work, as all doors had to be raised and extra steps built in to the stairs. This was yet another reason for replacing the lifts.

Stairs with extra step in front of door (raised floor)

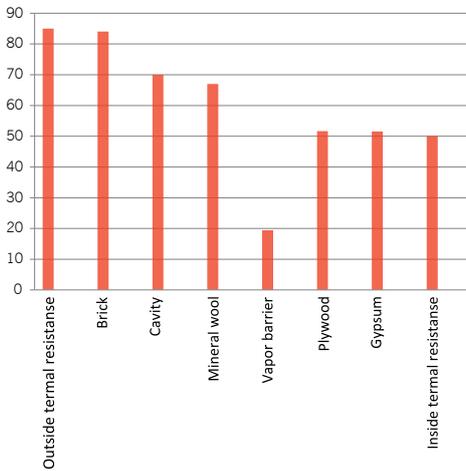
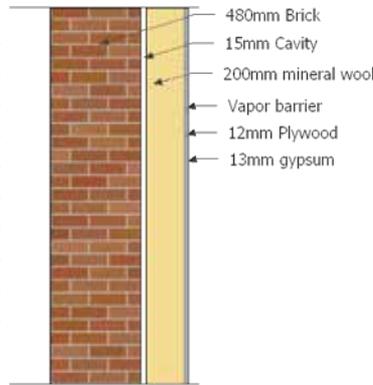
RH%, 200 mm insulation (Winter)

Such a high level of insulation requires mechanically-balanced ventilation to be able to maintain air humidity at a level at which there is no risk of condensation in the structure, and the subsequent development of rot and mould growth.

The contact areas where the stabilised brick inner walls and concrete floors are in direct contact with the outer wall construction represent a significant area – and a large cold bridge. This means that the dew point is pushed back into the building’s construction, creating further need for ventilation. The cold bridges cannot be reduced without extensive work on the construction.

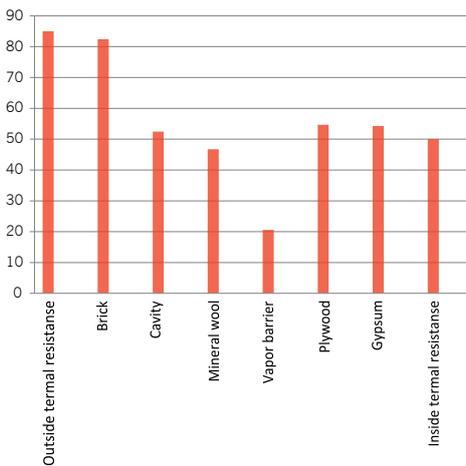
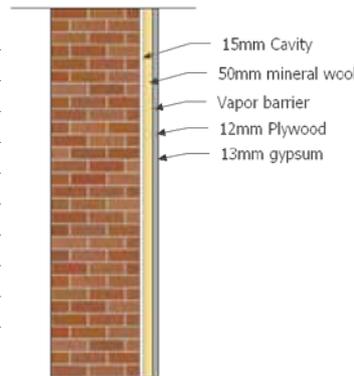
RH%, 50 mm insulation (Winter)

The cost-effectiveness factor for 50 mm insulation was calculated to 1.24, which is lower than the 1.33 deemed to be cost-effective according to BR08. The cost-effectiveness factor for 75 mm insulation was calculated to 1.36.

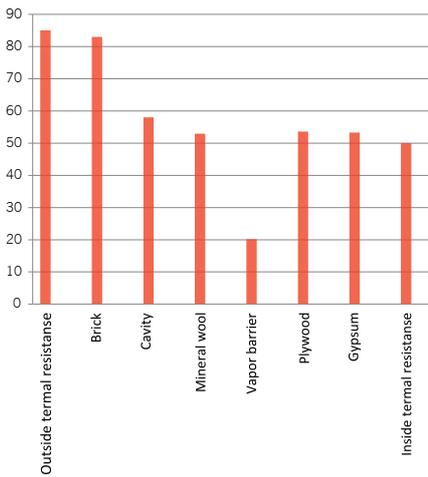
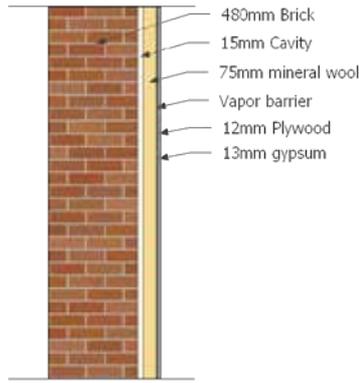
RH%, 75 mm insulation (Winter)

The option of additional insulation without mechanical ventilation was considered, for which new calculations were made particularly with regard to the dew point within the construction if a lesser amount of insulation was used. The calculations showed that right down to approx. 75 mm additional insulation would be required before an acceptable result was achieved with a guarantee of no accumulation of moisture in the building because of additional insulation.

The solution using insulation of 75 mm mineral wool could comply with the dew point calculations, but was not deemed to be cost-effective because of the inherent risks of the construction, even though the calculations showed that it was just possible, in theory. A further precondition was that there would be no unforeseen expenses for cost-effectiveness to be achieved, which is improbable for the renovation of an older building.

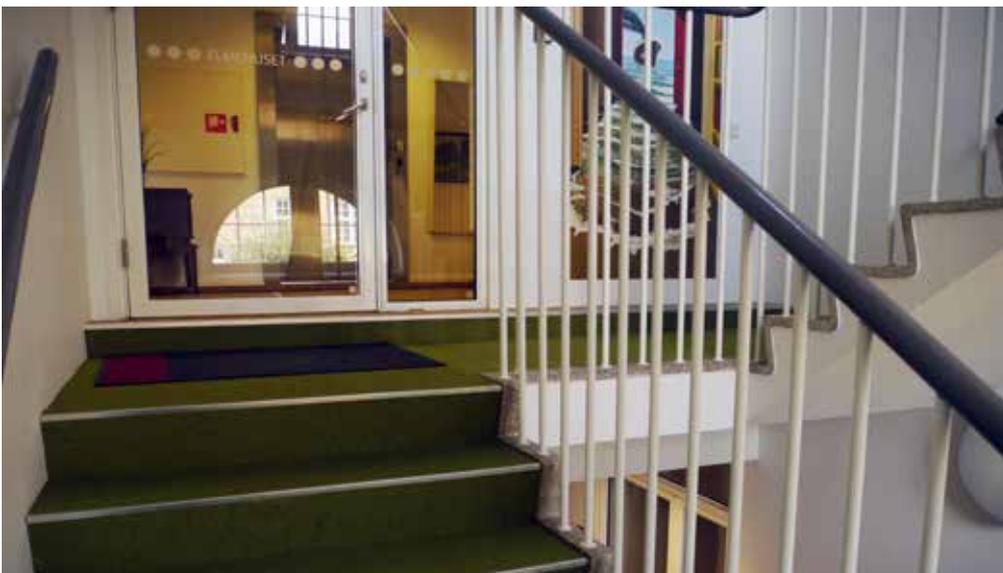
The strict requirements to noise suppression led to all floors being raised, including the stairs, which meant in turn that all doors had to be replaced. The existing floors consisted of linoleum laid directly on concrete, and a new lath layer was laid with pressure-resistant insulation between the wooden floors. The new lifts were also realigned to the modified floor levels.

Stairs with raised floor

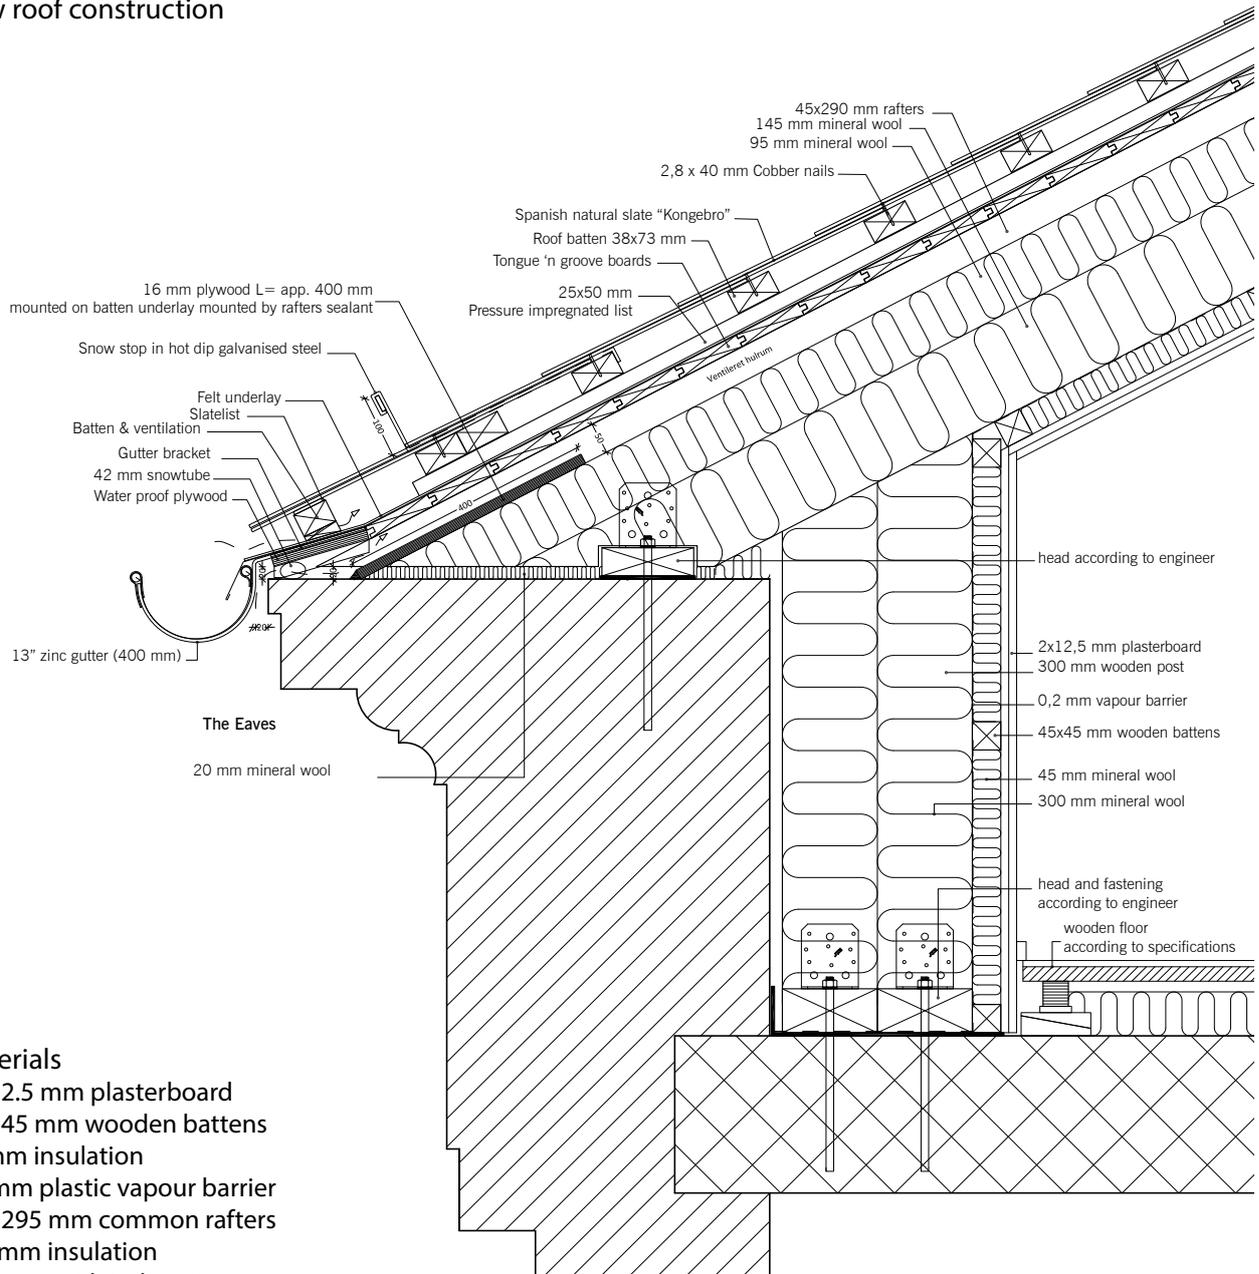
The roof construction needed replacing due to rot and mould attack. The scope and location of mould damage indicated that the existing roof construction had been installed incorrectly, and that the Haloten roof underlay prevented the necessary level of ventilation. Extra focus was therefore placed on the sealing and ventilation of a new roof construction.

- 2 x 12.5 mm plasterboard
- 45 x 45 mm wooden battens
- 45 mm insulation
- 0.2 mm plastic vapour barrier
- 45 x 295 mm common rafters
- 250 mm insulation
- 50 mm ventilated cavity
- 25 x 110 mm fixed roof underlay, coarse-planned tongue and groove boards
- 1 layer of roofing felt
- 25 x 45 mm spacer strips
- 38 x 73 mm T-1 battens
- 21 mm waterproof plywood footboard
- Natural slate tiles

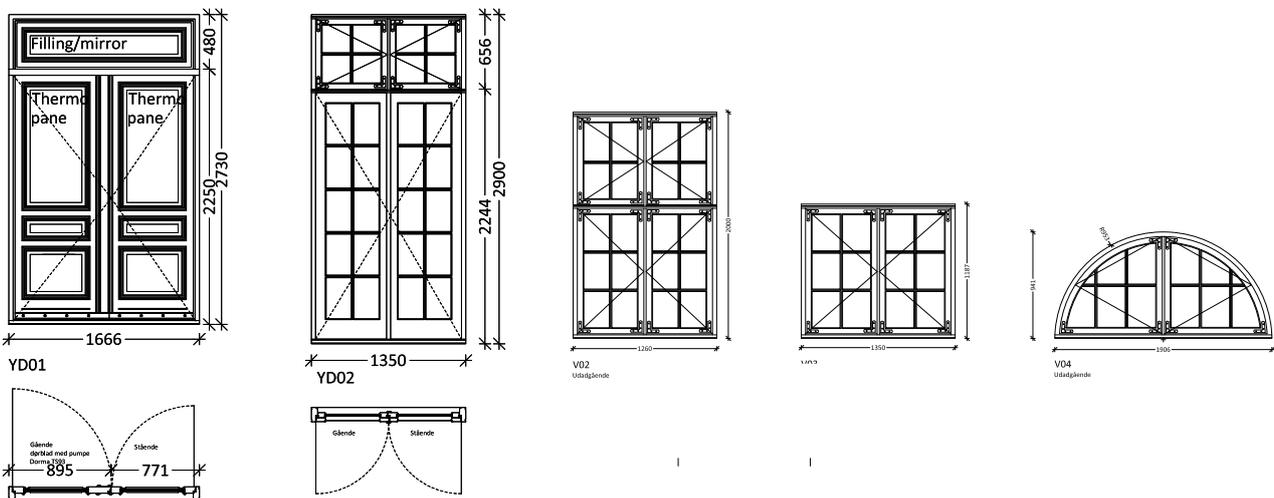
New doors and windows

The building's windows were replaced by new two-light windows with small panes and coupled frames and putty beading, with exactly the same appearance as the previous windows. However, the glazing in the outer frame is low-energy glazing with putty and small glazing bars. The internal frames have no bars, and contain double-glazing with a warm edge. All windows were supplied with a frame vent.

External doors were replaced by new ones with optimised insulation value, although with exactly the same appearance as the previous moulded doors.

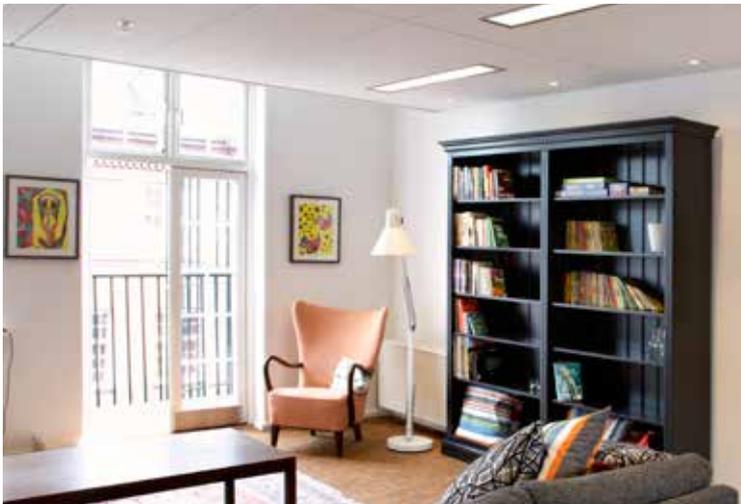
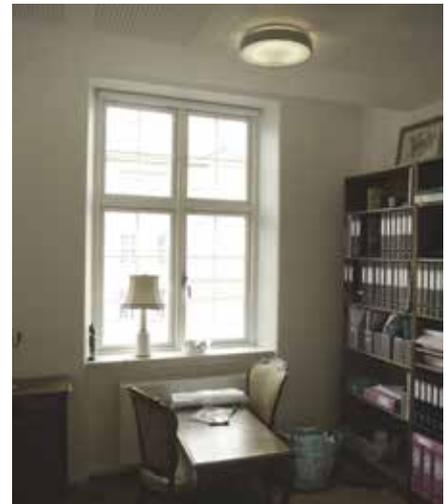
Light fittings in common room and office

Lights in offices and stairwells were fitted with low-energy bulbs and manual switches. The stairwell lighting is controlled by a dusk sensor switch. Lighting in the common rooms now consists of fluorescent tubes and LED spots.

Lighting in the toilets consists of compact fluorescent lights with manual switches, although PIR sensors are used in the staff toilets. Other lights consist of fluorescent lights with manual switches.
