Co₂olBricks

Improving the Energy Efficiency of Historic Buildings

The four pilot projects of Co₂olBricks

2. Model-reconstruction concept: Garden City 'Elmschenhagen-Nord', Kiel

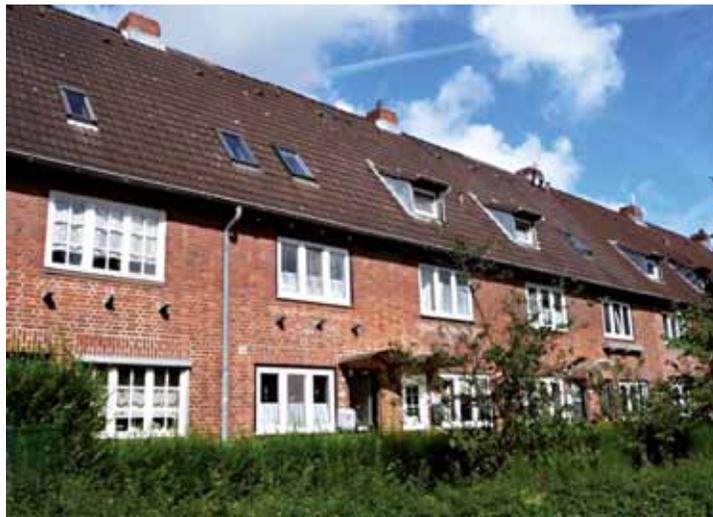
Figure 1: Row house, 'Kiel
Elmschenhagen-Nord'

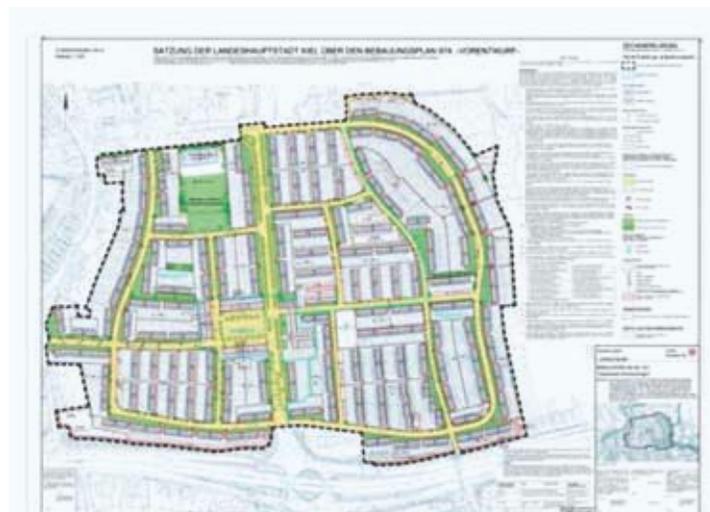
Figure 2: Binding land-use plan no. 974 'Kiel Elmschenhagen-Nord'

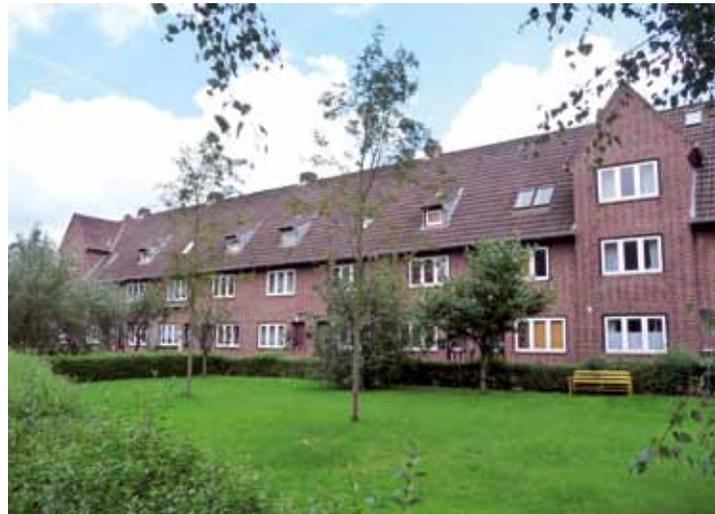
Figure 3: Row house type 296 and type 60, 'Kiel Elmschenhagen-Nord'

The row-houses of the settlement are essentially composed out of the following fundamental types. The gable, resp. townhouse type 296 with two apartments and a mildly protruding oriel, represents the distinctive end type of a house row. It has an axle width of app. 5.5 m and a building depth of 8.12 m. This house row is completed with the townhouse type 60 comprising one apartment on a foundation of 4.22 m by 8.12 m. Whereas the Type 92, as middle or end house, has a building depth of 8.65 m. Beyond that special types with shops or access balconies are to be found in the centre of the town.

Due to its frequency the middle-house type 60 was chosen as basis for the model reconstruction concept. For this house various examples for heating and insulation were conceptualised in detail and also calculated in different variations. With this method insulation measures were developed for all parts of the building shell. Subsequently several possibilities of heating systems were reviewed. In the next step the thermal and technical characteristics of a compiled house row, comprising out of eight middle-houses type 60 and two gable types 296, was examined.
